How the installation of grilles and re-roofing of a building in Dorset have allowed greater horseshoe bats (*Rhinolophus ferrumequinum*) to emerge earlier

Colin Morris

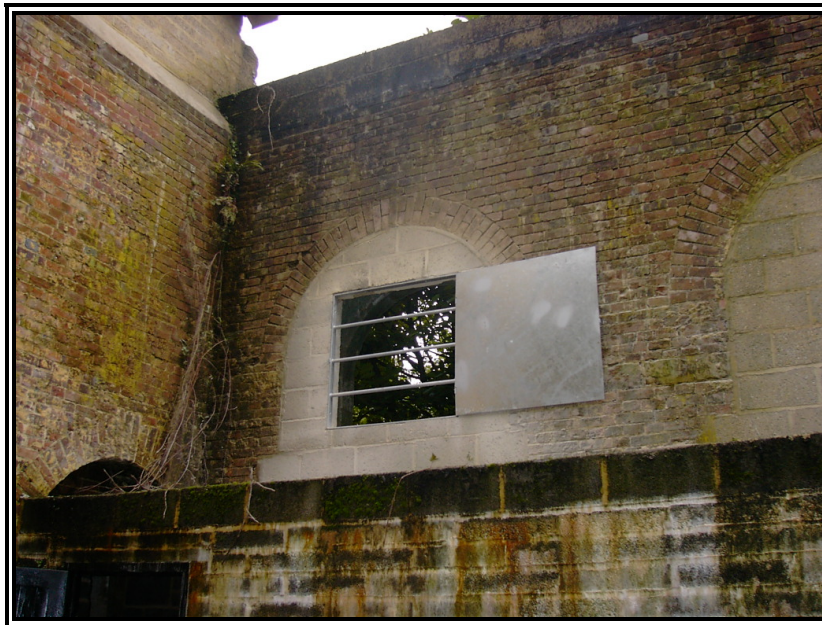
Figure 4. One of the two grilles in the eastern elevation wall – prior to re-roofing

The Vincent Wildlife Trust purchased the building from Bryanston School in 1994 and set about a programme of works to enhance and improve the bats' roosting opportunities and improve security. The asbestos roof was replaced with natural slate to improve solar heating and to also create a greater range of temperatures in the loft. Prior to this, the bats spent the vast majority of time roosting in the small heated area shown in Figure 2. The electrical wiring was also replaced and improved. In 2005 two grilles were installed in the eastern elevation walls to allow bats to emerge at a lower level than they could previously, which had been over the top of the 6m high walls. It also allowed them to emerge into dense vegetation. Security doors were fitted inside the grilles in case the bats did not use them and the building needed to be secured (Fig 4).

The roof over the courtyard has made this section of the building darker and allows the bats to fly safely in this area earlier in the evening. The grilles fitted into the east elevation wall also allow the bats to emerge into the dense/dark vegetation to the east. Prior to these alterations, the bats waited until it was darker before initially entering the courtyard then exiting over the courtyard wall.

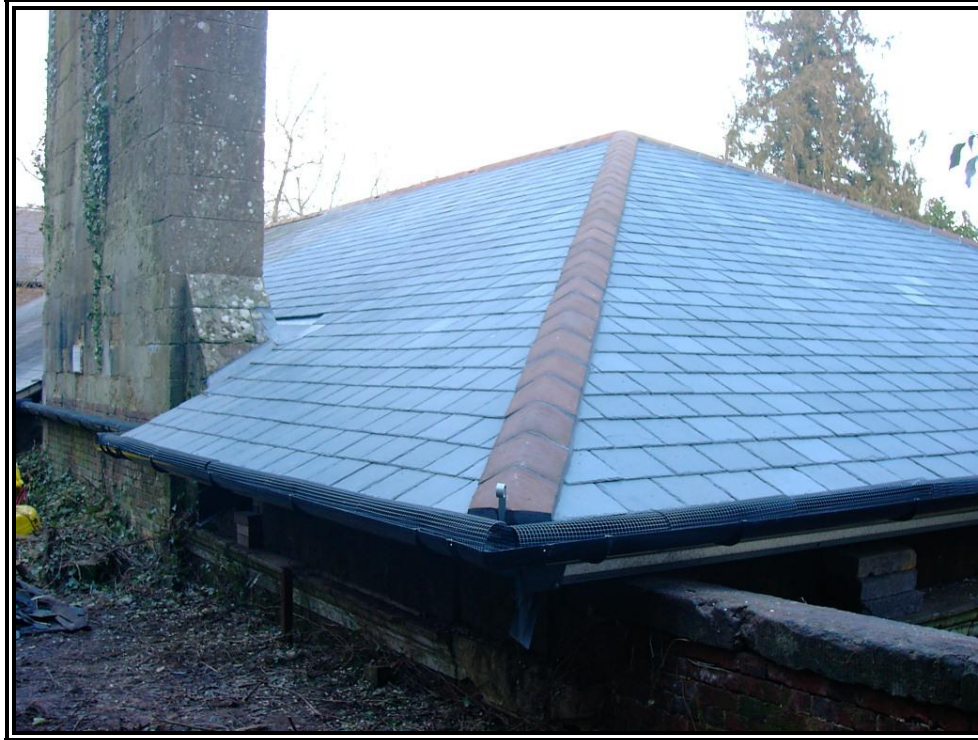
Figure 6. The final hip-end section on the southern elevation

Once the final section of the building was re-roofed (Fig 6) it was impossible to use the original observation position and the bats had to be counted from inside the woodland, approximately 10m to the south of the building. Once the bats exited the building, most of them spent at least a couple of minutes in the vegetation close-by before flying off into the woodland. The time at

The result of the roofing work was that the bats emerged significantly earlier ($\chi^2 = 36.16$ $p < 0.001$).
